## **SAFETY ALERT N°67**

### **11kV SERVICE STRIKE**

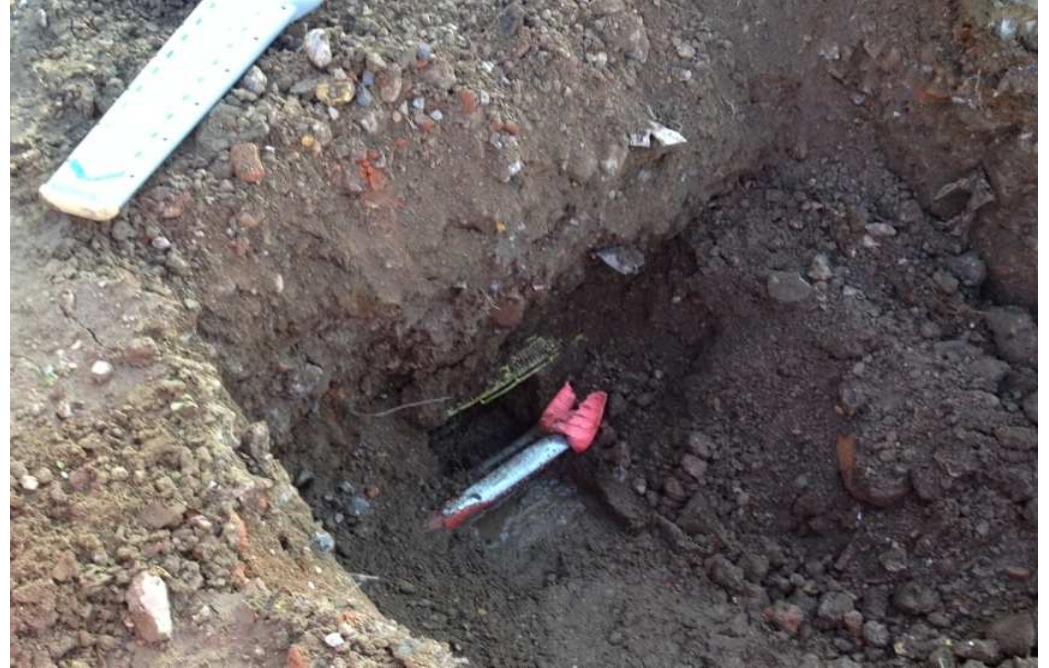
On November 18<sup>th</sup> at Abbey Mills, during the excavation of a manhole, an 11kV cable outer sheath was damaged. Operations were stopped right away and the cable was isolated and repaired.

This incident could have resulted in a fatality or serious injury if there had been contact with the high voltage electrical cable.

Digging operations can be hazardous and a Safe System of Work and hierarchy of control must always be implemented and followed. Safe working method includes:

- Acquisition of plans of the area of excavation: Drawings **do not necessarily show the exact position of the services**, but give indication of their existence and their approximate location
- Method statements and risk assessments must identify the potential hazards associated with the excavations
- A Permit to Dig should be used and must identify all the required controls and drawings
- Operatives tasked must be competent in the activity of digging
- All operatives involved in the activity must receive a task briefing, understand the risks arising from the activity

- Services should be precisely located and marked using detection equipment such as Cable Avoidance Tools
- Never assume cables are suitably buried, at a given depth or run in straight lines
- Personnel carrying out cable location activity must be trained and experienced

- Use of a competent top banksman to assist digging operations
- Mechanical excavators or power tools shouldn't be used within 0.5 metre of the suspected route of the underground services
- Buried services should be uncovered using careful digging by hand
- Uncovered services should be identified and labelled
