## **INC-55800 Conduit cut by Concrete Saw**

### Division - Eastern Infrastructure - Ultra Fast Broadband Project, New Zealand

Date	30/01/2013			
Site	150 Great North Road, Arch Hill, Auckland	Department	New Zealand	
Energy type	Electrical	(Potential) Damage	PC1	
Contact details	Name Mark Durham Phone 0064 27 733 2156 Email mark.durham@leicon.co.nz

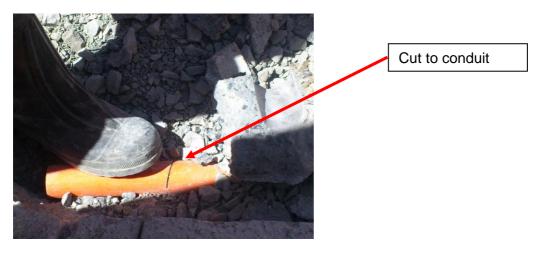
A conduit carrying an electrical cable was damaged when a worker cut through it with a concrete saw. The worker was cutting the concrete in preparation to reinstate the pavement after the installation of a pedestal box. The conduit contained a 240v cable which was feeding a street light. The electrical cable was not damaged by the saw.

This incident is currently under investigation but it appears that although the cable was identified the depth was unknown.

This incident is currently being investigated. Project Managers are reminded of the importance of the following controls:

- Every effort must be made to eliminate the risk of striking live services including de-energising or relocating the service.
- All services must be positively identified using the following for example Electronic detection – Ground penetrating radar – non-destructive pot-holing
- Ongoing verification of services must be undertaken at suitable intervals
- All services must be appropriately protected from damage and adequately sign posted
- A current permit to disturb must be in place and all persons must be briefed on the permit
- When changes occur to the methodology / depth or type of excavation, ongoing verification of services must be completed
