Serious Injury/ Fatality Safety Alert

Title: Contractor Fatality

Incident Date: January 4, 2013

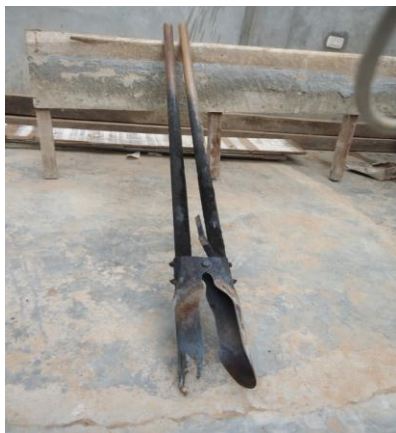
Post hole digger.

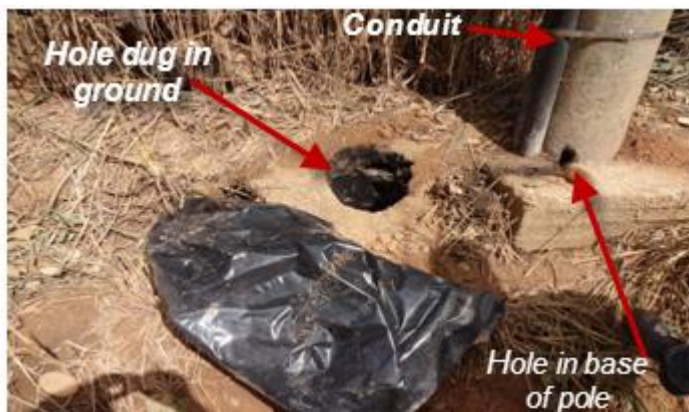
A third employee was digging a hole next to pole 7 with a manual post hole digger. He struck the underground 10 kV line next to the pole while digging with the post hole digger. He was thrown back into the road. The employee next to him, who was leaning over at the base of the pole, was electrocuted. It is not known how he made contact but his hands and feet were near the base of the pole.

The base of the pole showing the hole they were digging.

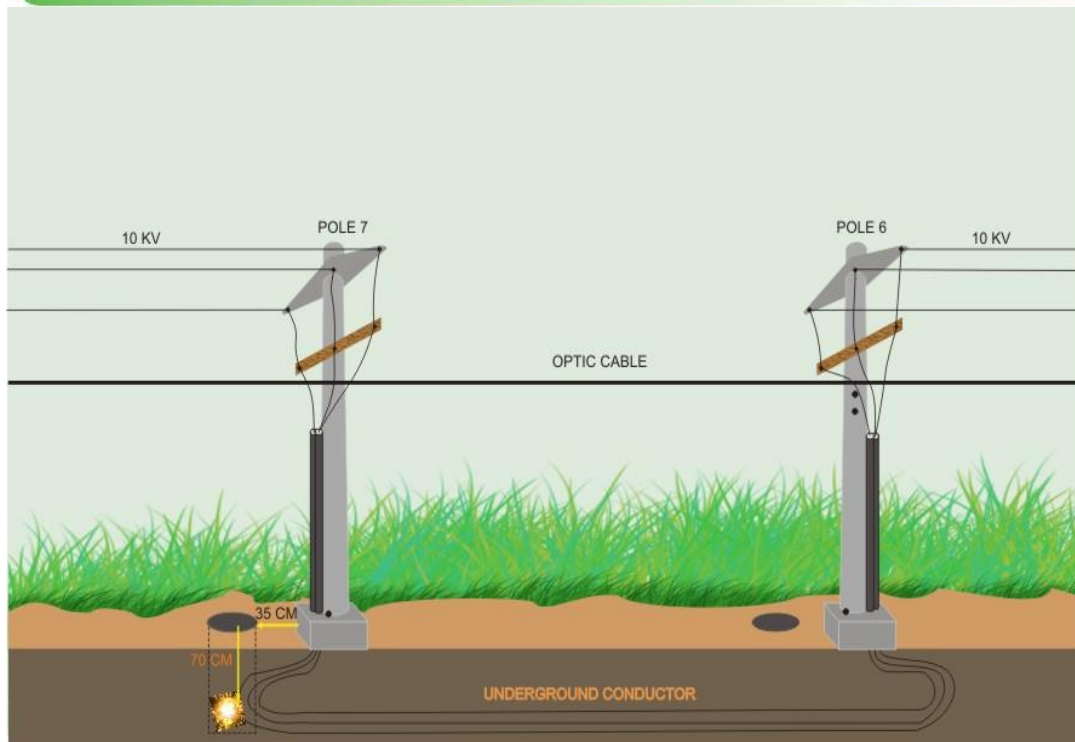
Diagram: 10 kV line is above ground except between poles 6 and 7 where it travels down in conduit and then underground. Note how the cable loops before it gets to its final depth. The contractors struck the underground cable to the left of pole 7 as shown.

- The contractor was not qualified for high risk work.
- The hazards of the work had not been properly evaluated or communicated.
- The underground lines had not been located or marked. The presence of an underground cable had not been communicated to the contractor.
- Oversight of the contractor was inadequate.
- The DEI contractor EHS management process was not followed.

Numerous corrective actions have been developed and will be implemented to strengthen processes for contractor management at this location.
