# Caval Ridge Environment Safety and Health Near Miss / Incident Notification Flash Report

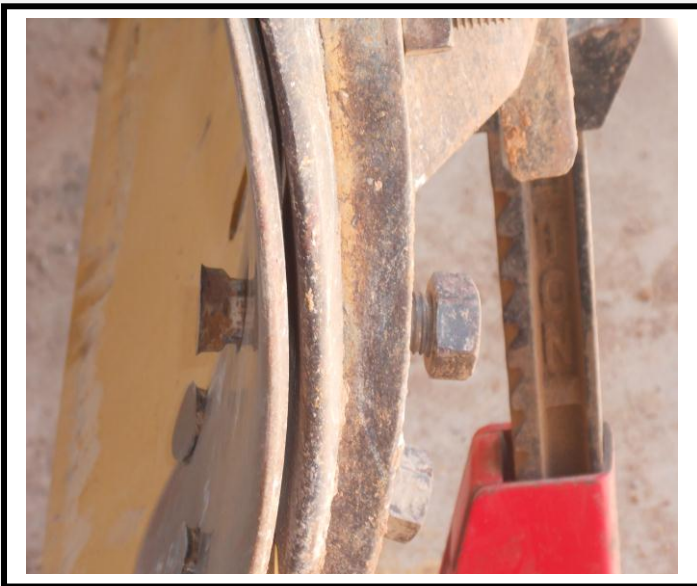
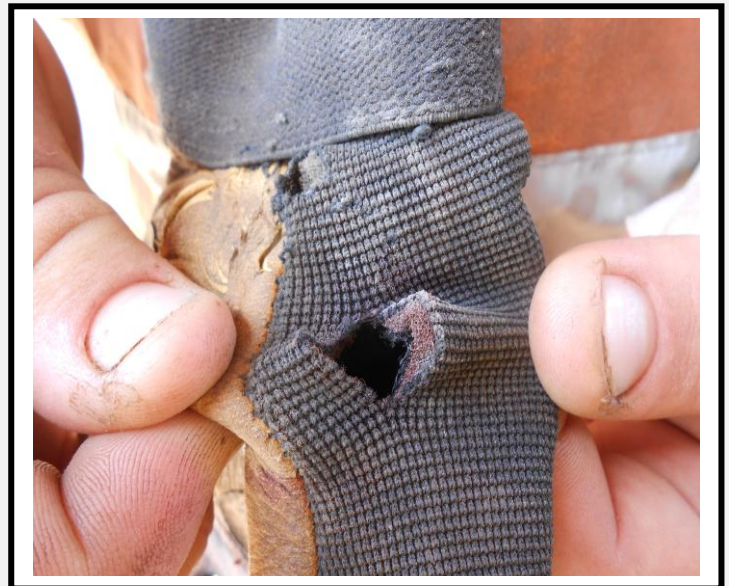
On Monday the 14th of October a Thies Earthworks Diesel Fitter was changing the cutting edges on a 140M grader at the Thies workshop. After changing the main cutting edges and the RHS overlay plate he was manoeuvring a bolt on the left hand overlay plate which had become unseated as he was tensioning up the bolts this final plate. He was using his right hand to pull on the threaded end of the bolt to align it with the retaining hole (the square edge on bolt has to be aligned for the bolt to seat properly in the edge) and he was also pushing on the head of the bolt with the palm of his left hand.

During this process of manoeuvring the bolt into position, his left hand, which was applying pressure to install the bolt, has slipped over the edge of the bolt resulting in his hand coming into contact with the sharp edge of the worn bolt. Although he was wearing gloves he has sustained a small cut to the fleshy part of his palm below the thumb. He was taken to the site medical facility where three sutures were applied. The worker has returned to normal duties.

Investigation identified a JHA for changing cutting edges was in place and signed onto by the fitter but it did not identify the potential hazard of sharp edges when reusing the worn GET bolts and placing them by hand.

The JHA for changing ground engaging tools has been modified to reflect the additional hazard and the control that when old bolts are removed, they are to be inspected for condition, any identified as having a sharp edge on either the head or thread end are to be replaced.
