ZHA15-14

Worker Struck by Damaged Guardrail

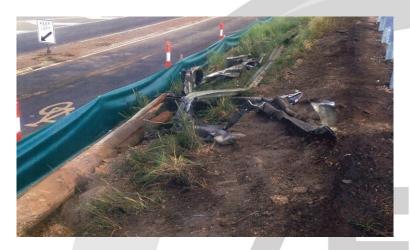
- A contractor was in the process of dismantling a section of damaged guardrail. As he separated the
 guardrail components from the post, a section of damaged rail moved towards the worker's hand
 and struck him. The sharp corner of the rail pierced deep through his nail and into his thumb.
- The injured person was provided immediate care then taken to a local medical facility for further treatment where he underwent a minor procedure to save the remaining nail and treat the injured thumb. The injured person was given two days off work and is receiving medical treatment.

- The damaged guardrail was significantly twisted and under stress therefore once the two guardrail components were separated the stored energy was released and moved towards the worker dismantling the guardrail.
- A number of factors contributed to the incident including working on a steep embankment and the work was conducted by one person.
- Although an on-site risk assessment and pre-start had been conducted the contract workers did not
 consider nor identify adequate control measures to manage the risk of workers being struck by stored
 energy in the twisted and damaged guardrail components as they were dismantled.

- Stored energy hazards need to be eliminated in the first place and if not possible stored energy should be isolated and then released under control. Refer to the Toolbox Topic on Stored Energy (Aug 14).
- Ensure workers are not in the line of fire when stored energy is released.
- Ensure work processes are reviewed and updated and hidden hazards involving stored energy are recognised and control measures implemented.
