# HSE SERIOUS INCIDENT ALERT

Safety - Rear trailer in road train configuration dislodged from turntable

Incident date - 30<sup>th</sup>/6/2015

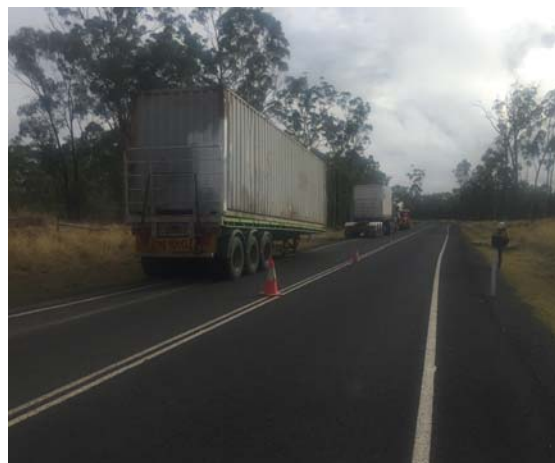
- A sub-contractor was transporting sea containers being demobilised from site.
- After coupling and loading trailers the operator performed a tug test and traversed off site.
- Whilst travelling at a speed of approx 40Km/hr the rear trailer dislodged from the turntable.
- The trailers adjustable landing legs contacted the bitumen causing damage to the road.
- The incident occurred on Origin GPF Access Road.

- The king pin beneath the trailer became dislodged from the turntable.
- The turntable cam track was subjected to build up of grime and debris.
- Operator did not check to confirm that the jaws had closed around the kingpin before driving.

- Investigation is currently underway - results and key learning's will be shared when available.
- Coupling of a trailer behind any vehicle must be done in accordance with the manufacturers specifications.
- Turntable (Fifth Wheel) must be visually inspected to confirm that jaws are closed around the kingpin after performing the 'Tug Test' as per manufacturers specifications.
- Regular inspection and maintenance must be undertaken on turntable to ensure grime does not impact the capacity of the internal workings to effectively function.
- Review 'Loading and Unloading Checklist' to incorporate verification of positive visual inspection of locking jaws.
