SAFETY ALERT N°69

PACKAGING OF STRONG BACKS

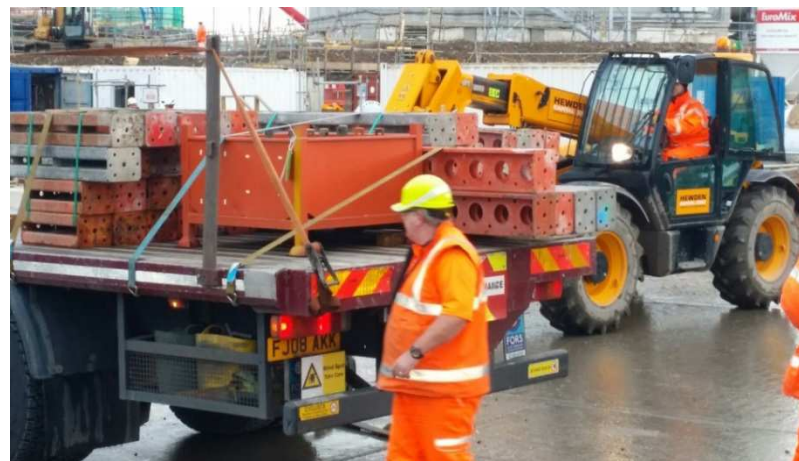
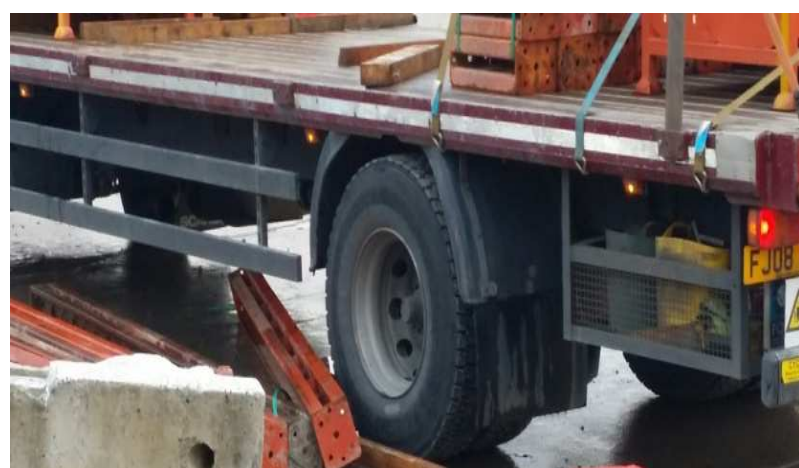
On the 11th of January, during the unloading of strong-backs from a low loader using a telehandler the plastic banding around a pack of the strong-backs failed causing the strong-backs to fall into the exclusion zone that had been set up around the lorry.

- ✓ The team did well inspecting the delivery upon arrival and checking the security of the equipment prior to removal of any strapping.
- ✓ It was noted that the green plastic banding securing the individual strong backs seemed light, hence the creation of an exclusion zone to the rear side of the wagon, preventing anyone from entering into the offloading area.
- ✓ The telehandler operator was briefed about the potentially weak banding to the strong back packs and the caution required when approaching the load.
- ✓ The incident was reported to the supplier.

- Assess the delivery and check if it is safe to go forward with the unloading (securing of the load, edge protections when access/egress is required on the trailer);
- When applicable, follow the manufacturer's instructions stated in the lifting plan for a safe operation;
- Establish an exclusion zone to the opposite side of loading/off-loading;
- If possible and safe to do so, further banding or ratchet straps should be installed to secure the equipment;
- Make sure you use the suitable lifting equipment and lifting accessories, as per the lifting plan;
- If there is still doubt about the security of the load then it should not be unloaded. Further assistance should be requested or the load sent away.
