SAFETY ALERT # 14.07

Title: Non-Secured Load Fatality

LOCATION: Oudtshoorn – Western Cape

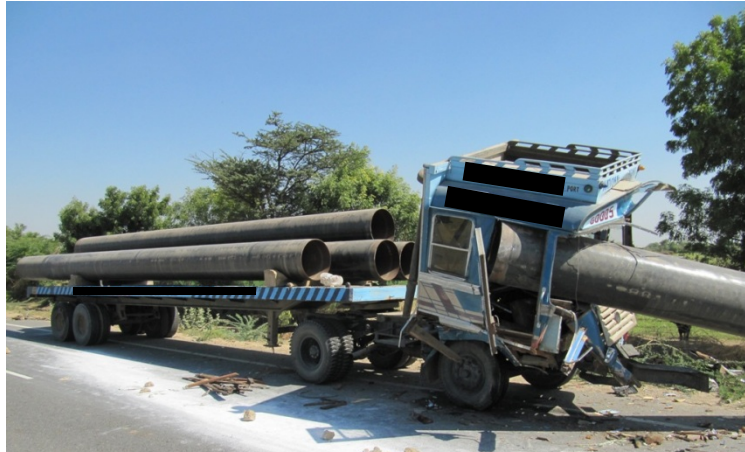
Truck after breaking hard and unsecured pipe travelled forward

The truck, taking pipes to a pipeline project close by, had to suddenly apply the brakes to avoid an animal straying on to the road. The driver was killed instantly, his body found in two parts, the bottom half in his seat, the top half inside the pipe. The co-driver was impaled on a second pipe, forced through the windscreen and was found dead 17meters ahead of the truck.

- The driver/operator had not checked the load security after the first few kilometres driven.
- An animal coming onto the road caused the vehicle brake and to come to an abrupt stop.
- The vehicle flat-bed trailer was not fitted with a headboard.
- Securing mechanisms on the trailer were insufficient for the weight and momentum of the load. There were no forward or backward restraints.
- It is thought that the lack of tension straps was because the pipe journey was a short distance and the driver and co-driver “thought they would save time”.

- Common loads should have a loading plan and drivers must ensure the load is fully secured before travelling. Best practice is to have a trip checker at the security gate of the pipeline supply depot or yard. This is a double check to ensure nothing has been missed.
- Stop after 5km – 10km into the journey to check securing mechanisms are still tight.
- Vehicle body should have a headboard capable of withstanding shock load.
- Risk Assessment and Safety Task Analysis to be conducted prior to execution of the task
