# HSSE SERIOUS INCIDENT ALERT

## Safety -Excavating near buried Gas Pipeline

Incident date - 15 May 2014

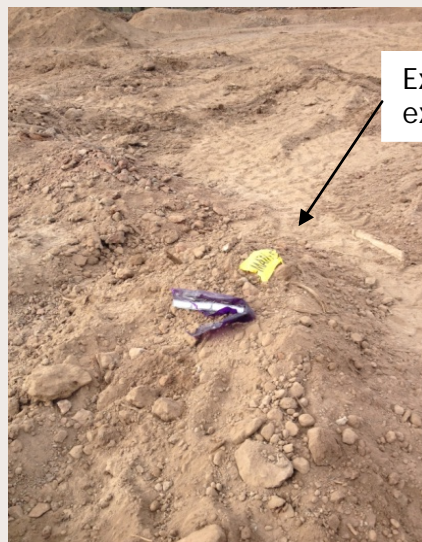
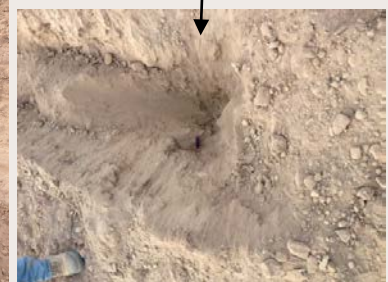
- While installing a flare pit liner a backhoe operator exposed service marker tape for a gas gathering HDPE pipeline.
- A spotter who was at the excavation, observed the exposed marker tape and immediately notified the operator to stop work.
- The exposed line was not live and had not yet been pressure tested.

- The information provided to the excavation crew suggested it was a Greenfield area with no underground services.
- There was no signage present indicating buried services in the immediate area

Exposed Marker Tape and excavation top view

- Ensure all excavation activities are undertaken in accordance with the Origin Excavations Directive ORG-HSE-DVE-042 and relevant worksite transfer, excavation and PTW procedures.
- Always request the latest 'as-built' information for excavation work including 'Dial before you dig'.
- Ensure any landowner pipes not registered with dial before you dig are identified.
- Always use a spotter for excavation activities.
- Investigation is currently underway - results and key learnings will be shared when available.
