### Procedural breach while cleaning mobile rock crusher

#### INCIDENT SUMMARY

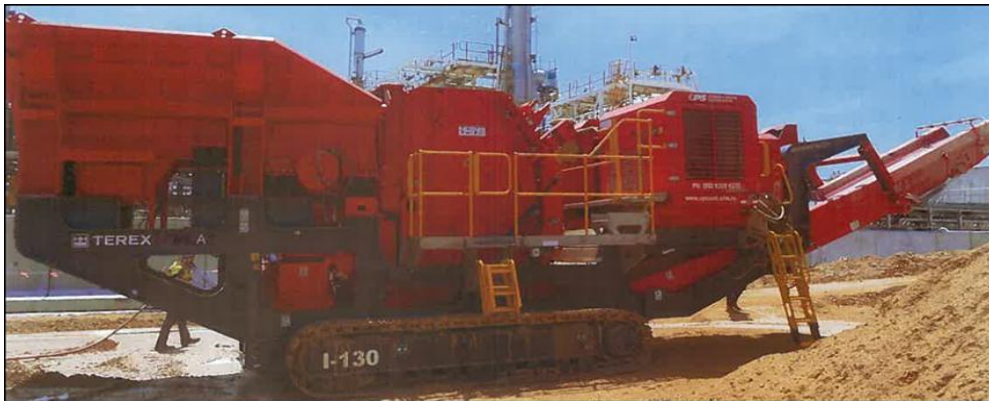
During a routine site walk around, it was realised that a person was cleaning the mobile impact crusher from inside the machine with the key still in the ignition.

The job was immediately stopped and an incident investigation was initiated.

- The contractor's training/ personnel matrix will be audited against current and future works.
- A debrief session with contractor personnel has been conducted that included reiterating of the sites' Permit to Work and ISA requirements.
- Lessons learnt regarding adherence to permit to work standards and procedures will be rolled out across all Australian operations.
