**Haulotte HA18PXNT Knuckle Boom**

**Inspect Hydraulic/Fuel Hoses and Cables**

**03/07/2015**

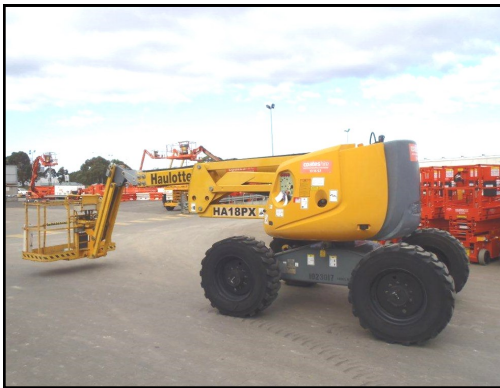
Fig. 1: Haulotte HA18PXNT

There has been an incident where the main battery cable and a hydraulic hose on a Haulotte HA18PXNT Knuckle Boom have worn through resulting in fire. See Fig. 1, 2, & 3.

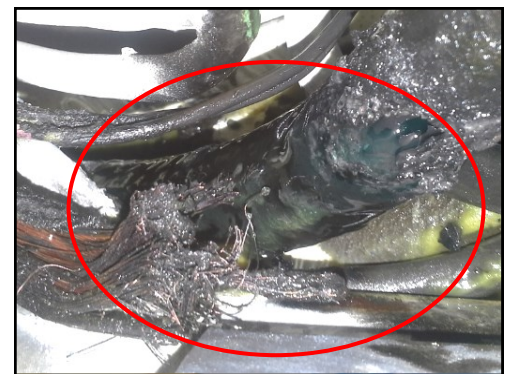
Fig. 4: Fire Damage

The hydraulic hose and battery cable rubbed together resulting in the outer insulation on both the hydraulic hose and battery cable to wear away exposing the battery cable strands and the metal hydraulic hose braiding. This caused the battery cable to short circuit causing the fire. Due to the high current carried in the battery cable the short circuit severed the battery cable. See Fig. 4.

1. As soon as possible all Haulotte HA18PXNT Knuckle Booms are to be:
  - i. Inspected to determine if there is wear or damage to the hydraulic/fuel hoses or cables. See example Fig: 5.
  - ii. If there are signs of wear or damage replace hydraulic/fuel hose or cables.
  - iii. Use spiral wrap to provide protection at potential wear points.

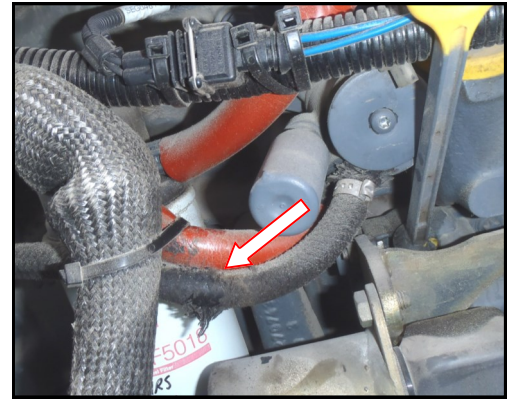
**Fig. 5: Wear & Damage**

Haulotte commonly use spiral wrap cable or ties to gather and secure hoses and cables across all product groups. If the spiral wrap or cable ties do not adequately hold the hydraulic/fuel hoses or cable they will rub together and wear through the outer insulation over time.
