Zero Harm Alert

ZHA15-34

Contact with Overhead Power Lines

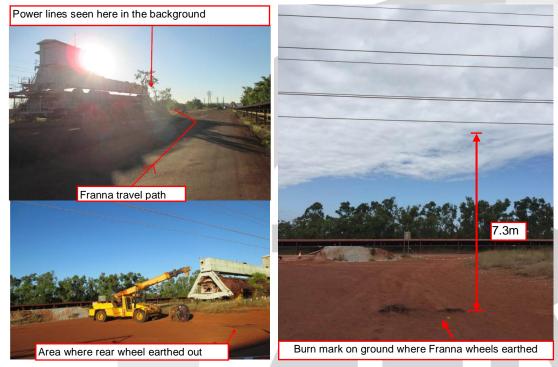
Two employees were using an 18 Tonne articulated Terex Franna to transport and relocate a cable drum to a workshop storage and lay down area located approximately 1.2 km from their work area. Both employees were inside the cab of the Franna at this time as they were mobile with the secured load. They had just turned left off the main access road whilst approaching the workshop storage and laydown area and came in contact with unidentified 22KV Overhead Power Lines. Operator immediately lowered the boom, reversed back and exited the vehicle. They then saw the overhead power lines close to the crane.

- The HV overhead power lines had no signage warning road users of the presence of overhead power lines, voltages and clearances all other access roads are clearly signposted.
- A large redundant reclaimer beside the main access road partially blocked view of overhead power lines and angle of the sun at the time of incident resulted in it shining into the eyes of the crane operator when turning the corner.
- Crane team decided to 'travel' load with boom at >7.0 m rather than stop and 'shorten' load chains.
- No risk assessment specific to 'travelling' the load to the laydown area was undertaken.
- No Permit to Work / Authority to Work had been issued to the work crew for the area they were working in.

- Cordoned off area and access road below power lines.
- Fitness for work testing undertaken inclusive of ECG results all clear.
- Commence ICAM investigation with Client.
- Restored power.
- NSW EC&M mandate that Route Survey and supervisor sign off is required for any load 'travelling' with boom above 4
 metres until further notice.
