# Stair module failures on scaffolding

The purpose of this safety alert is to highlight the potential risks associated with stair module failures and to provide guidance on ways to minimise the risk of this occurring.

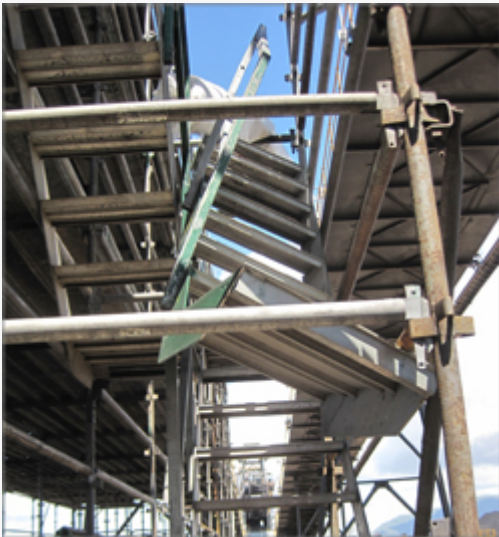
**Photograph 1 - Single width aluminium stair module after one incident**

In one incident, several welds at one end of a single stair module failed when a worker stepped onto the landing. The top of the landing peeled away causing the stair module to drop off the supporting transom. As the worker fell, his hand was caught on the V-pressing of a standard and a finger was torn off. Photograph 1 shows the stair module after the incident. Photograph 2 shows part of the module that peeled away when the worker stepped onto it.

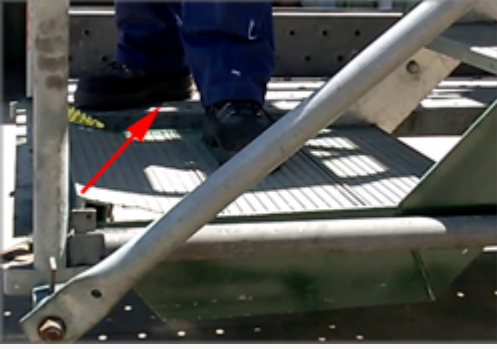
**Photograph 2 – Aluminium deck peeled away (as indicated by arrow) when a worker stepped onto it and the stairs dropped.**

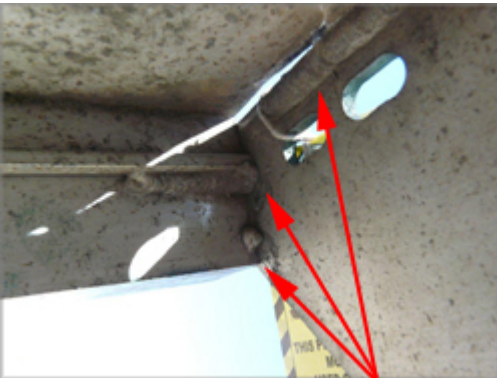
**Photograph 3 – Underside view of failed module welds (shown by arrows).**

Stair modules should be strong enough to withstand the loads applied during use, installation and transport. Tack welds should be avoided as they are more prone to cracking and failure. Welds should be continuous or stitch type welds.

- Checking the stair modules are the correct ones to use on the scaffolding in question.
- Inspecting all welds for any visual defects including cracks and undercuts in the welds.
- Identifying and removing units that have welds or components different from the design.
- Inspecting the modules for straightness, damage and excessive wear.

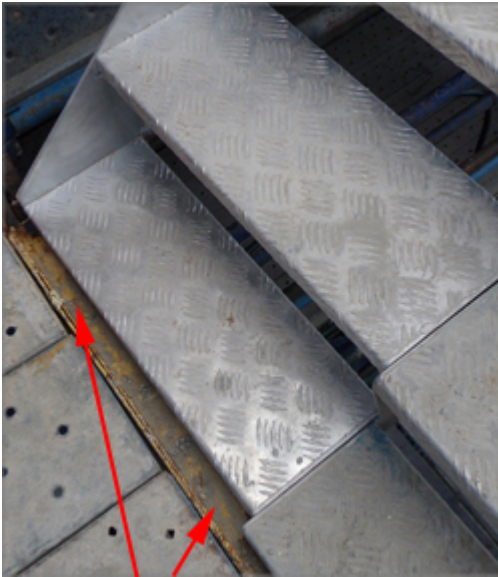
**Photograph 4 – Excessive gap on transom (indicated by arrows).**

- Inadequate support provided by the scaffolding transoms underneath both ends of the stair module, for the width of the module. In other words, the gap between the end of the module and the vertical face of the transom is too big (see Photograph 4) – often caused by the stair module being too short or the scaffolding not being square.
- Insufficient welds being located at critical points of the stair modules – often due to 'tack' welds being used instead of continuous or stitch welds (see Photograph 3).
- Stair modules, including welds, being damaged or cracked – particularly during assembly, dismantling and transport.
- The supporting transoms underneath the stair module being able to twist or rotate – possibly due to loose connections.

All modular stair units are to be adequately supported by scaffolding transoms at both ends of the module, with the module being pushed hard up against one of the transoms (i.e. so that there is no gap at one end). The maximum allowable gap between the vertical part of the transom and the end of the stair module is not to exceed the manufacturer's specifications. As an indicator, the maximum gap between the stair module and the

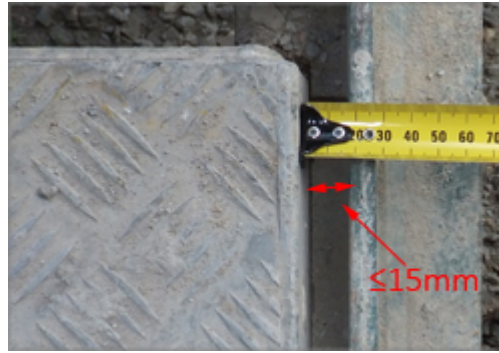
**Photograph 5 –The gap between the vertical face of the transom and end of stairs should not exceed 15 mm (unless otherwise specified by scaffolding manufacturer).**

- an additional lock system is not provided (examples are shown in Photographs 6 to 10).
- the gap does not exceed 15 mm, anywhere along the length of the supporting transom. Refer to Diagram (a) and Photograph 5.
- transoms with a horizontal width of at least 45 mm are used.

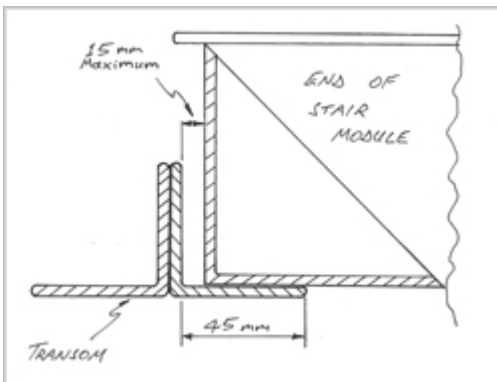
**Diagram (a) – Sectional view through transom showing maximum gap of 15 mm.**

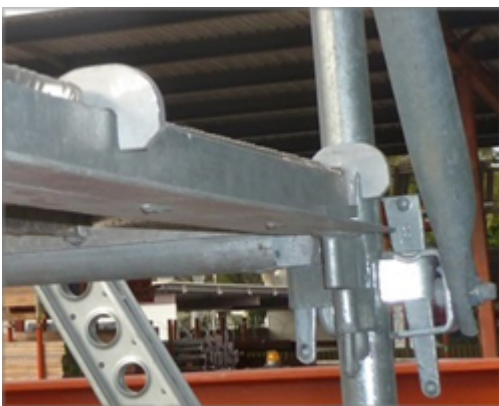
**Photograph 6 –Lock hooks over transom.**

Some scaffolding manufacturers and suppliers provide additional locking systems on the stair modules to help prevent the modules dislodging. These systems include hooks that pass over the top of the transom, a prop under the stair module and clamping systems. Photographs 6 to 10 show four different examples of locking systems used by some scaffolding suppliers in Queensland. While these systems do not have to be used on all stair modules, they are to be used wherever the scaffolding manufacturer or supplier approves and specifies their use.

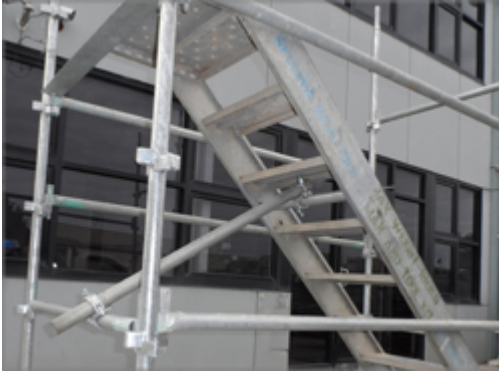
**Photograph 8 – Prop underneath stair module.**

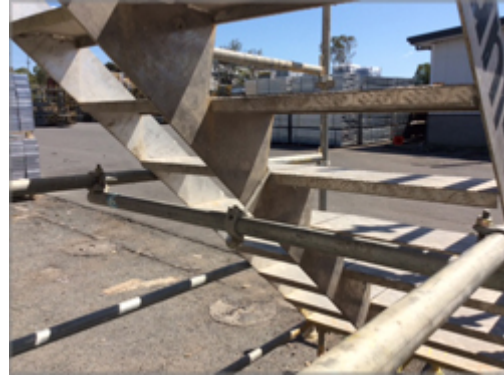
**Photograph 9 – Horizontal tube under stretcher stairs.**

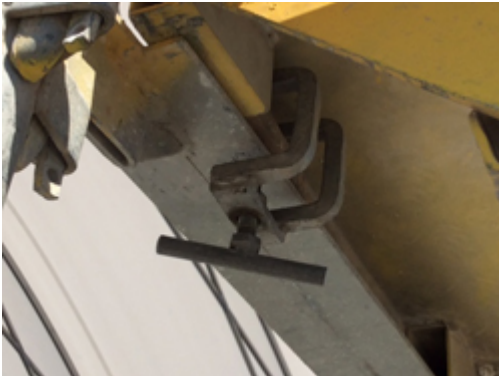
**Photograph 10 – Clamp securing stair module to transom.**
