Significant Safety & Health Incident Alert

Worker exposed to fall from height

Division	Infrastructure		
Date	24/01/2013		
Site	ILC Enfield	Business Unit	Eastern Infrastructure
Energy type	Gravitational	(Potential) Damage	PC1
Contact details	Name Jeffrey Bowers Phone 0433692811 Email Jeffrey.Bowers@leicon.com.au

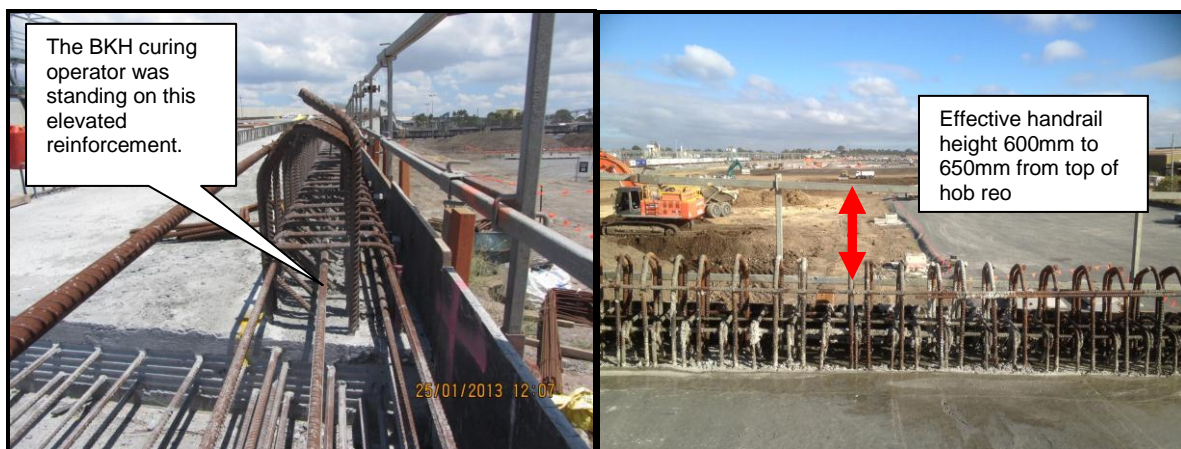
Photograph 1

In order to gain access to a section of the footpath to enable concrete curing, a BKH worker walked on an elevated hob reinforcement adjacent to the handrail (refer to photograph 1), this act exposed the worker to a risk of a fall from height of approx 4m as the effective height of the handrail was reduced to 600-650mm (refer to photograph 2).

WEXDEK FORMWORK PTYLTD (Trading as BKH) was engaged by the project to undertake concrete works on site. The incident occurred during a deck pour on the northern side of the ramp. When the concrete placement was finished, curing of the main carriage way was undertaken by hand lance off a previously poured section of concrete. However the curing lance was not long enough to reach across the freshly poured concrete to the foot path area on the north side of the ramp (the foot path is on the edge of the ramp adjacent to a temporary handrail system).

- Ensuring that effective planning of activities is conducted considering all potential hazards.
- Providing suitable equipment that enables tasks to be conducted safely and productively.
- Supervision must be diligent in ensuring workforce members conduct work safely and comply with the requirements of their SWMS and pre starts.
- Where a risk of fall from heights is identified, put in place, where possible, physical barriers to control the risk.
- Site inspections and task observations must always identify the potential impact to others presented by a task being performed
