<b>SAFETY NOTICE</b>	<b>EAF SN 13 001-01</b>
----------------------	-------------------------

<b>SUBJECT:</b>	<b>"Pick &amp; Carry" Cranes : Anti-Two-Block Switches</b>
-----------------	--

<b>MODEL(S) AFFECTED:</b>	<b>MODEL(S) All Crane Models fitted with ATB switches on Boom Head</b>
---------------------------	--

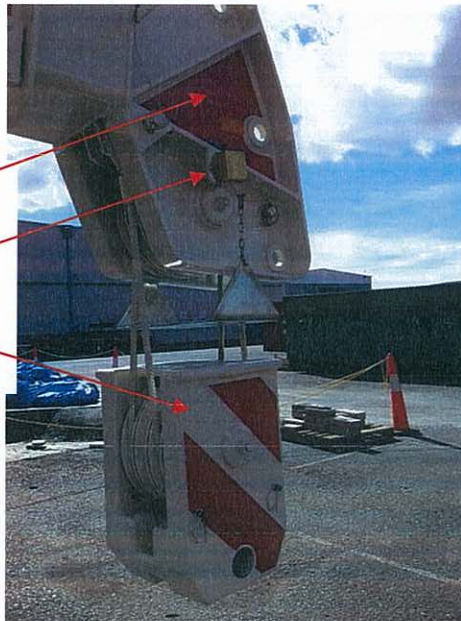
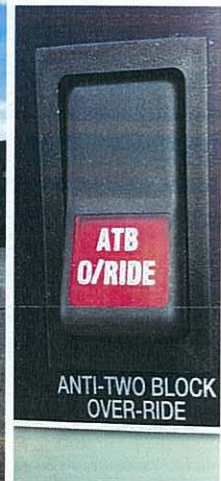
- Boom Head
- Anti-Two-Block Switch Assembly
- Hook-Block

<b>ACTION / METHOD</b>	<p>As soon as possible but not later than 7 days from receipt of this bulletin, perform following actions:</p> <ul style="list-style-type: none"> <li>- Update the crane operators manual as per attached instructions and attach to the relevant section under "Daily Pre-operational Checks".</li> <li>- Ensure ATB functionality is checked on a daily basis before use</li> <li>- Instruct your crane operators on this Safety Notice</li> <li>- Sent back the work completion form to your Terex partner (see last page 5 of this bulletin)</li> </ul>
------------------------	---

<p><b>WORKING INSTRUCTION:</b></p> <p>Ref Terex WI:</p>	<p><b><u>Additional Instructions in Operator's Manual:</u></b></p> <p><b><u>Daily Operation Inspections:</u></b></p> <p><u>Operators must perform daily startup checks to ensure the Crane's Anti-Two-Block function is operational before use.</u> The ATB motion cut will stop the winch up function if the hook block approaches the head of the boom. In addition when tele-scoping out the 3<sup>rd</sup> phase of the boom, motion cut can also occur when the hook block approaches the boom head as this section does not compensate the winch rope during telescoping.</p> <p>Two –Blocking the hook block against the boom head can cause excessive stresses to boom components resulting in internal damage or failure of the winch rope causing the hook block and load to fall to the ground.</p> <p>Some older Pick &amp; Carry Cranes are fitted with ATB switches with plastic housings. These plastic housing are prone to damage from boom head contact with obstructions or environmental deterioration. This can affect the operation of the switch if damaged. Newer Cranes are fitted with a metal housing to provide added protection. It is important that operators always check the operation of the ATB function to ensure safe use of the crane.</p> <p><b><u>Anti-Two-Block Over-ride:</u></b></p> <p>Operators must never engage the ATB over-ride switch under load from winching up and/or telescoping out the 3<sup>rd</sup> Phase of the boom. Again, Two-blocking the hook block against the boom head will cause damage to boom components and possible failure of the winch rope.</p> <p><b>Remember : As Operators, Safety is your priority!! Always check ATB function is operational before use and do not use override under load as falling loads and hook block can causing significant damage, serious injury, or death.</b></p>
