Lifting and Rigging Plans

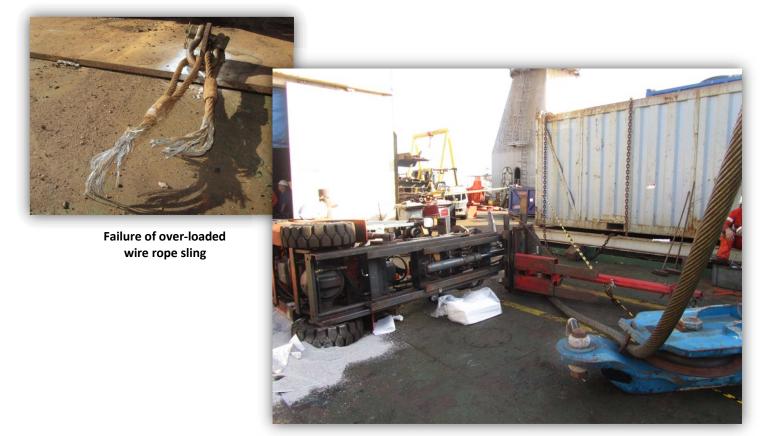
- A manned forklift, which was being utilised to suspend a rigging equipment arrangement, toppled-over on the
 deck as a result of rigging equipment failure. An investigation identified that, contrary to the operator's safety
 management system, the rigging operation was conducted without a rigging plan and without rigging loads being
 determined for any part of the operation.

Toppled forklift (manned at the time)

Lifting or rigging plans should be completed in accordance with the facility safety management system, and should be:

- completed for every lifting or rigging operation (routine and non-routine)
- completed by suitably trained and competent personnel
- reviewed by a competent person
- approved by the supervisor of the lifting or rigging operation to ensure all of the identified controls are in place prior to commencement and remain in place for the duration of the activity.
