# Safety Alert

## SMALL ROLLER OVERTURN – POTENTIAL OPERATOR CONTAINMENT RISK

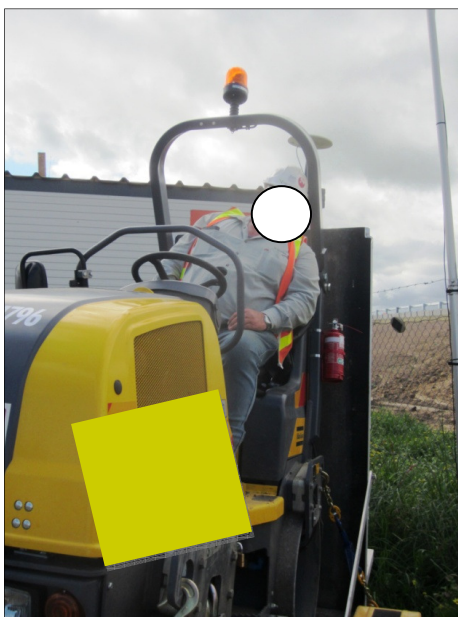
**Potential for operator to strike head on ROPs.**

Rollers which confine operators within the machine so their body cannot protrude outside the frame of the machine during an overturn should better protect operators. This is particularly important during road works near high batters where a machine could roll a number of times. Larger machines with cabins are usually used on larger size road works and better confine operators, but with open doors operators can and have been ejected during overturns involving full roll-overs when they were not wearing their seat belt.

**Seat belts must be worn to prevent the operator being ejected from the machine as per the OHS Regulations.**

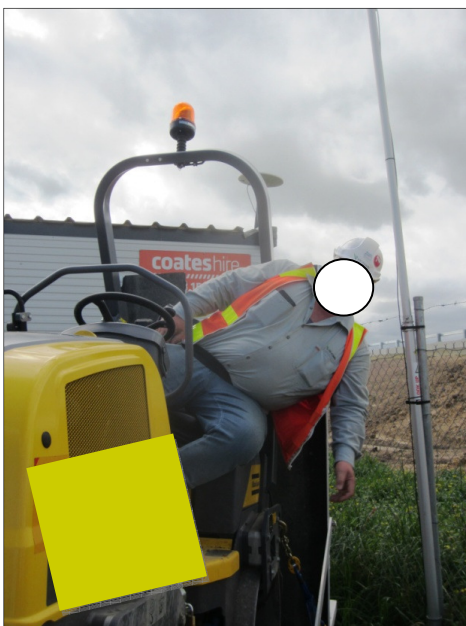
**Head, torso and arm well outside of roller with seatbelt worn.**

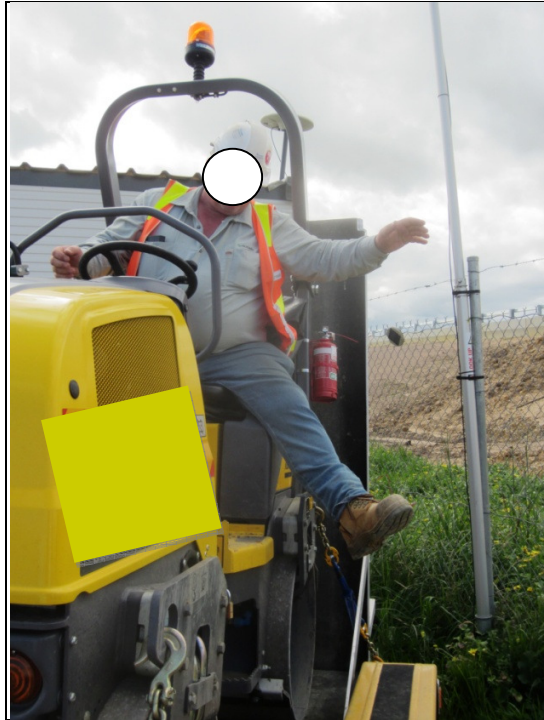
**Arms and legs could protrude outside roller.**
